Debris/Ice/TPS Assessment and Integrated Photographic Analysis of Shuttle Mission STS-85

*Gregory N. Katnik
Process Engineering/Mechanical System Division/ET-SRB Branch,
Kennedy Space Center, Florida*

**DEBRIS/ICE/TPS ASSESSMENT
AND
INTEGRATED PHOTOGRAPHIC ANALYSIS
OF
SHUTTLE MISSION STS-85**

7 August 1997

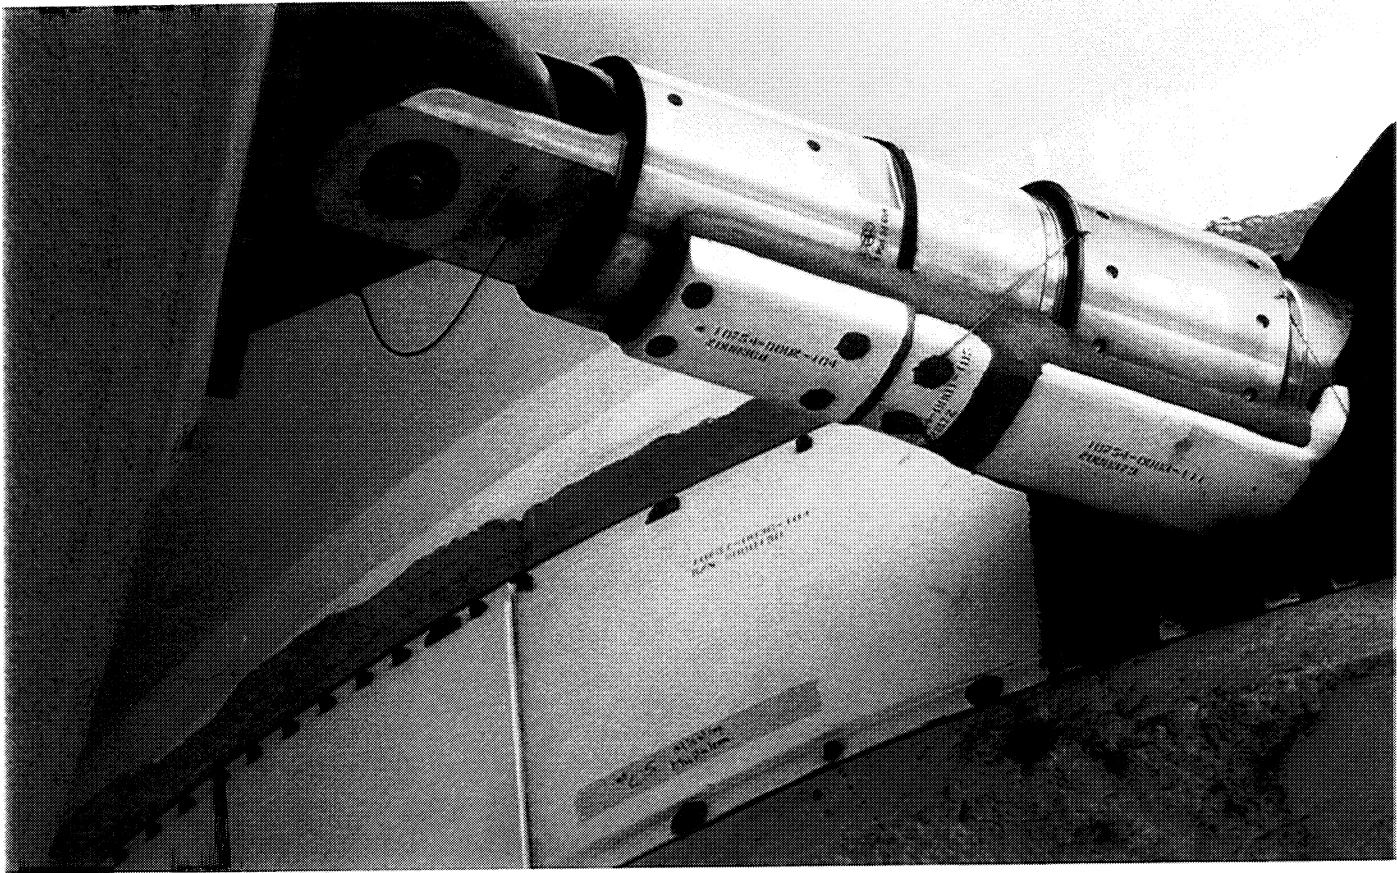
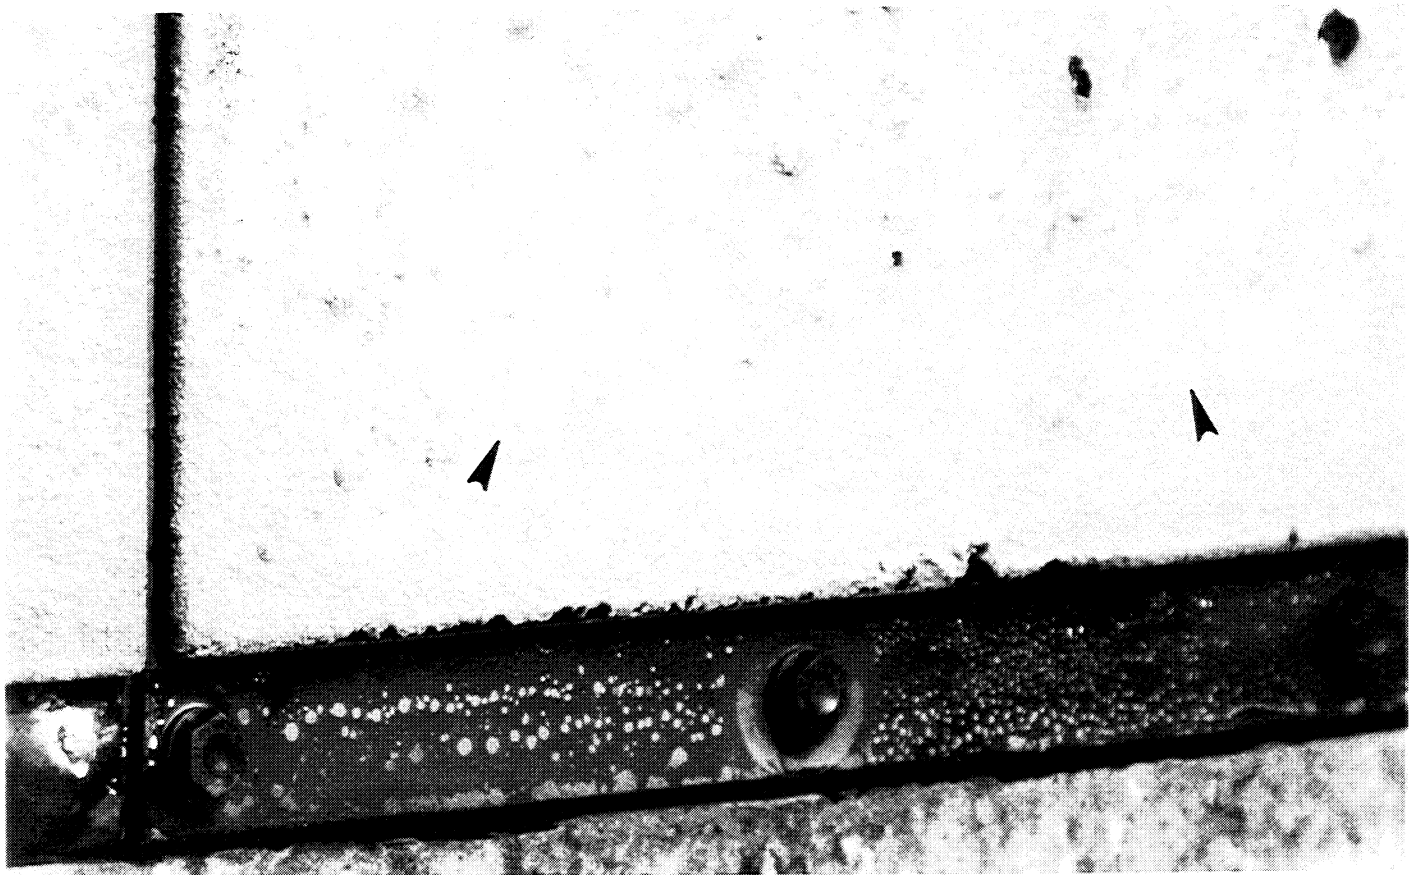
Photo 14: Vinyl Tape on ETA Ring

Yellow vinyl tape that had flown attached to the left SRB ETA ring near the lower strut was gone, but a faint outline on the Hypalon paint could still be seen

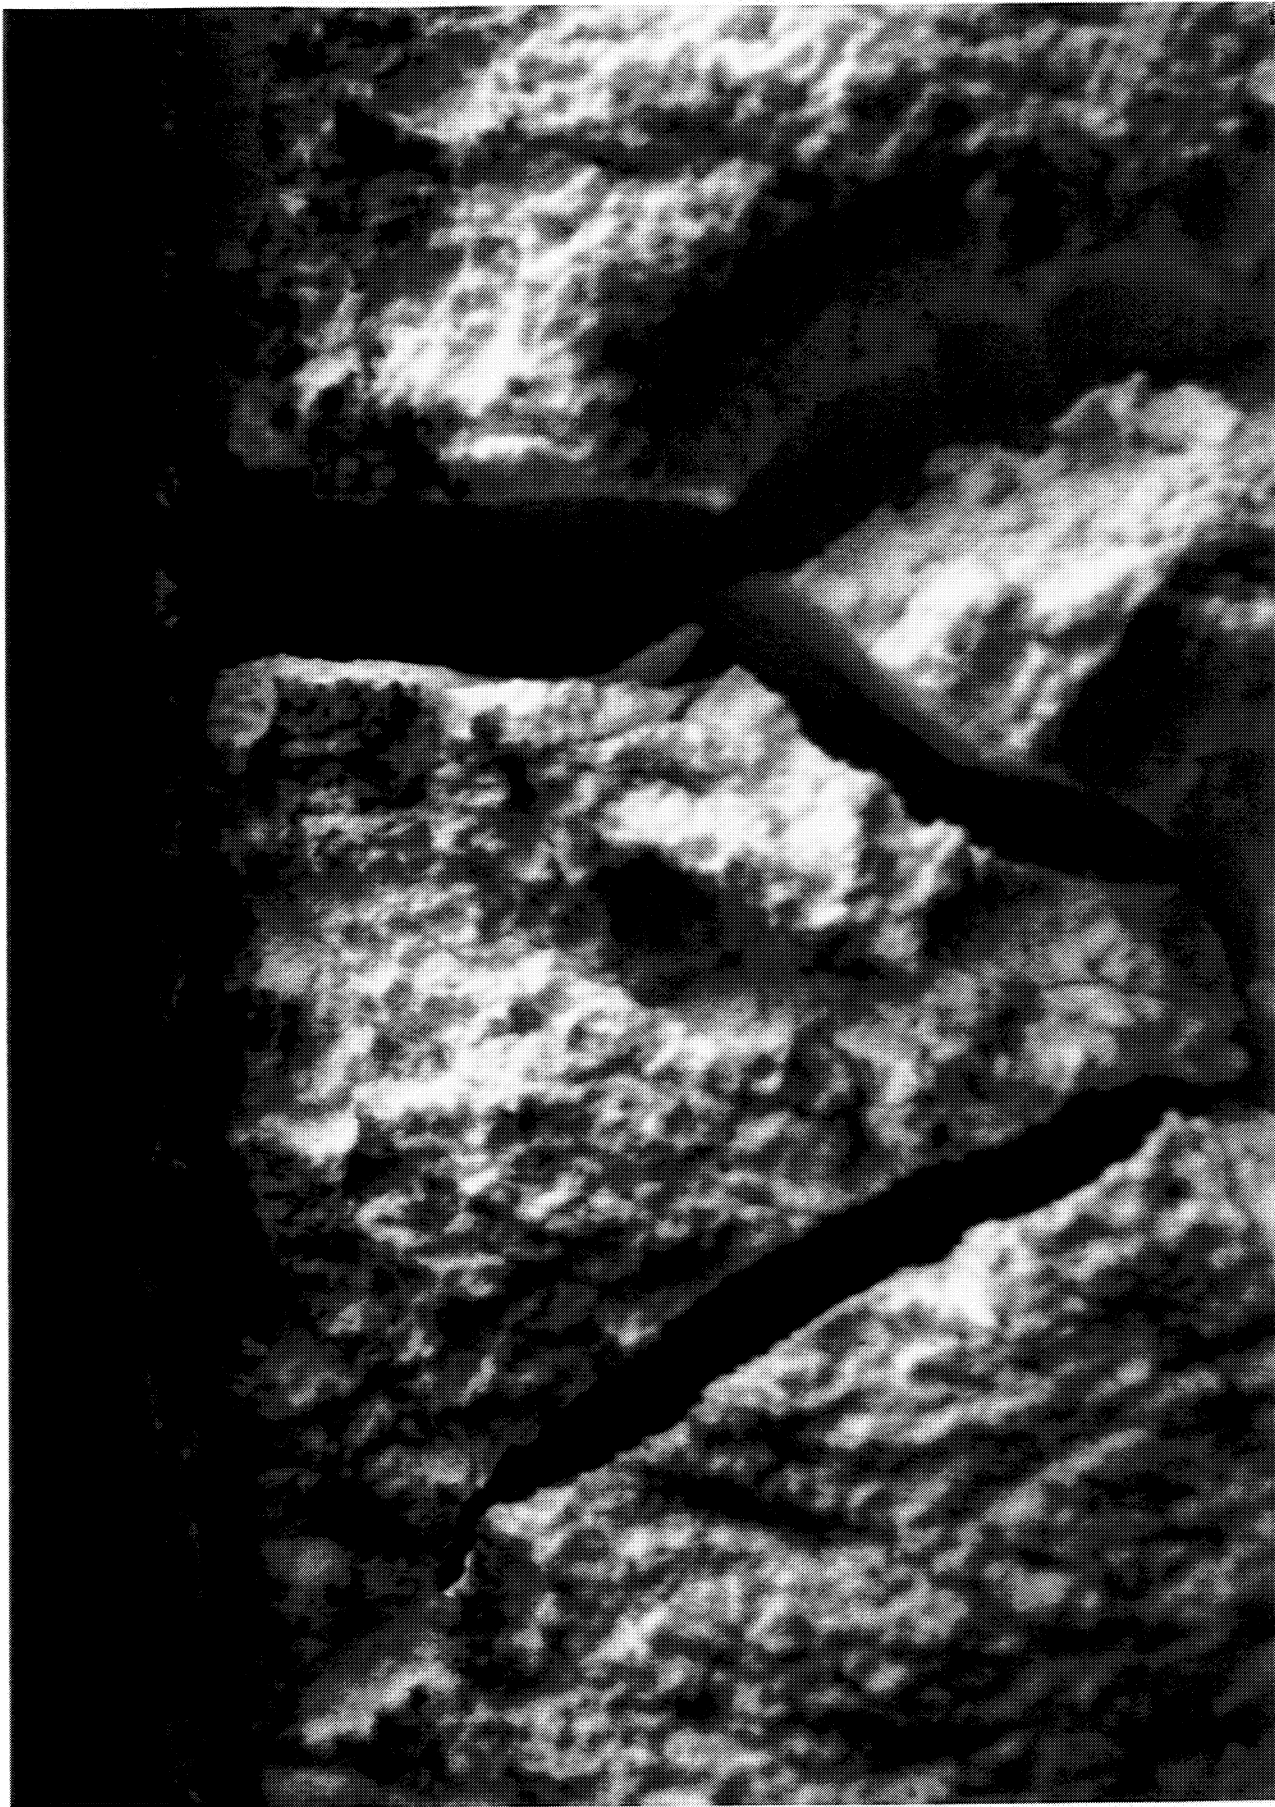
Photo 15: Stiffener Ring Foam Shrinkage

Instafoam aft of the left SRB stiffener rings had shrunk causing separation from the trailing edge of the stiffener rings as well as fissures in the foam. Some of the fissure surface area appeared glazed as if exposed to heating.

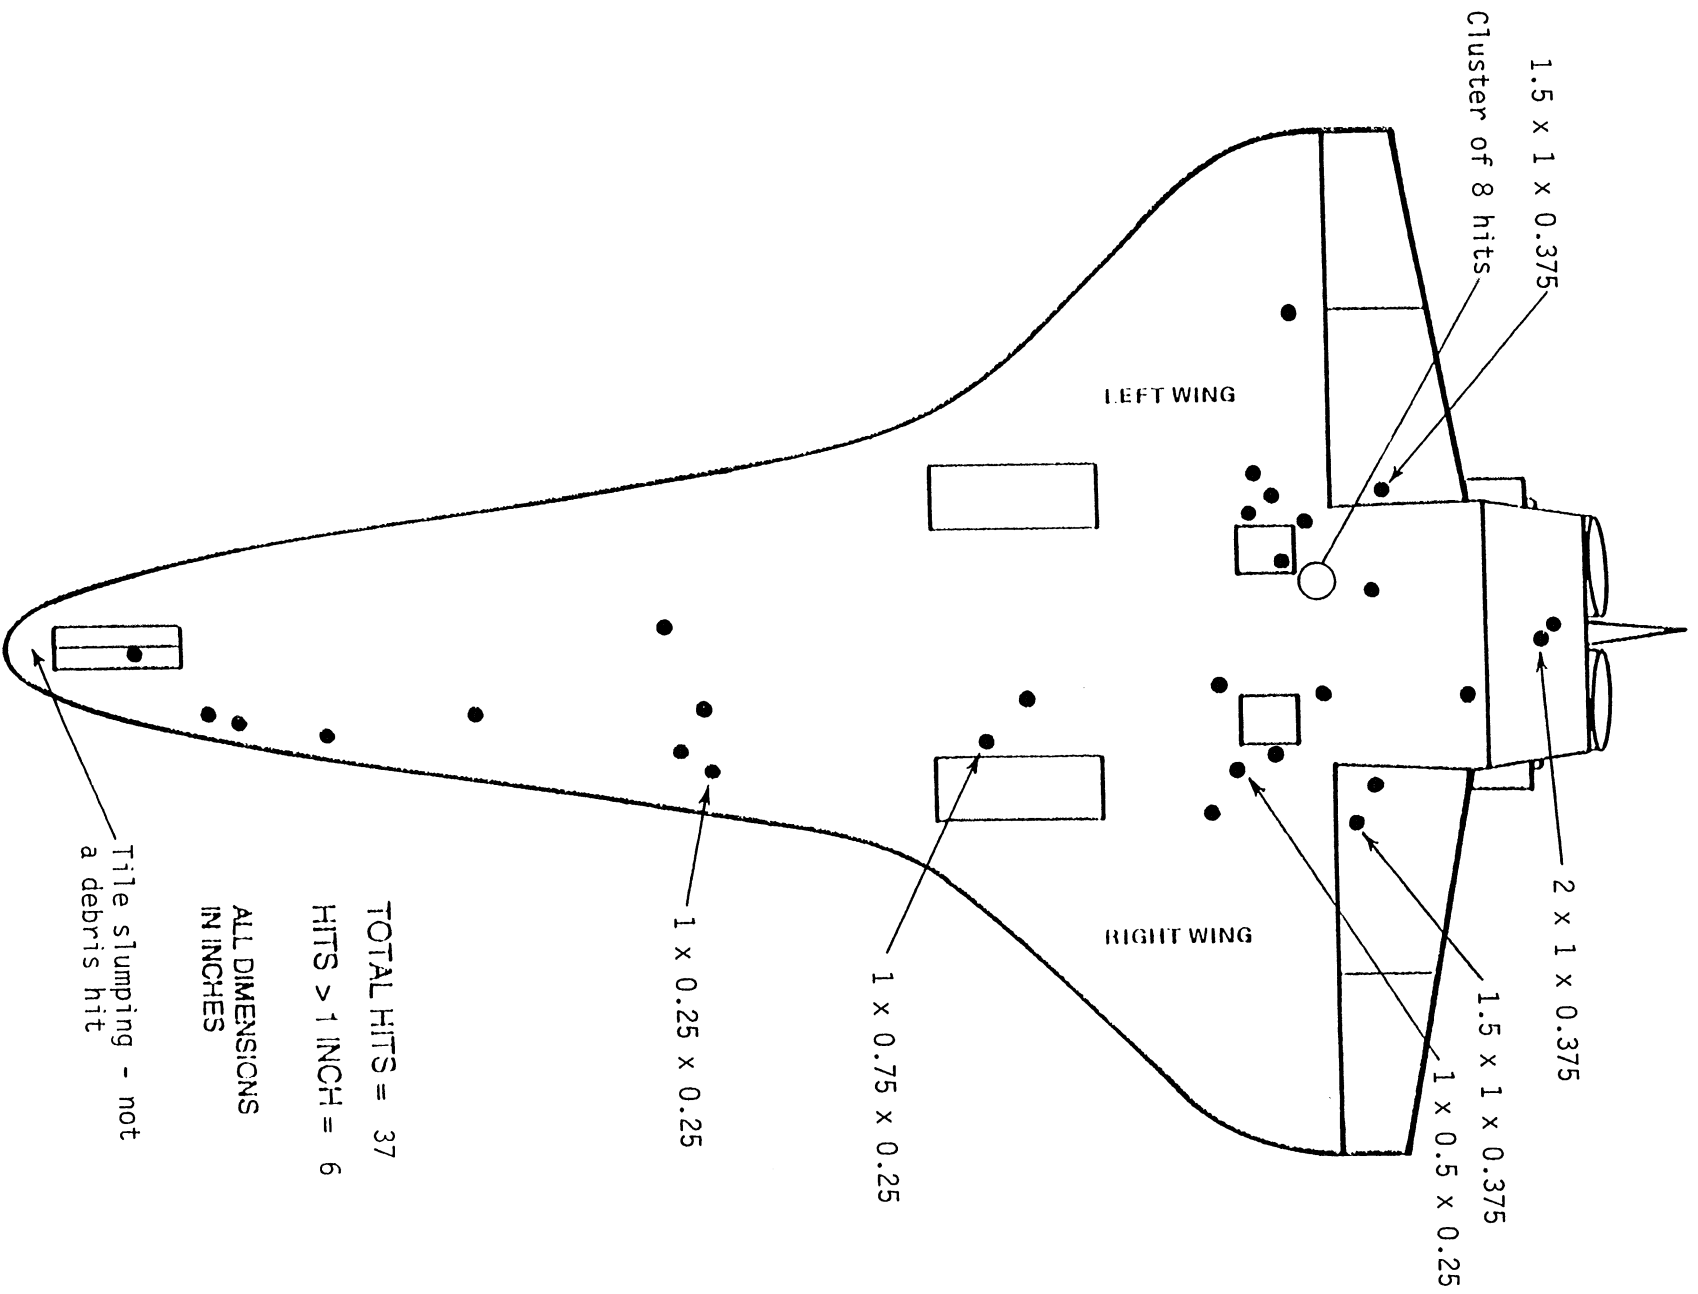
Figure 1: Orbiter Lower Surface Debris Damage Map

The Orbiter lower surface sustained a total of 37 hits, of which 6 had a major dimension of 1-inch or larger. The largest lower surface tile damage site was located on the body flap centerline. The site measured 2-inches long by 1-inch wide by 0.375-inch maximum depth and was probably caused by an ice impact.

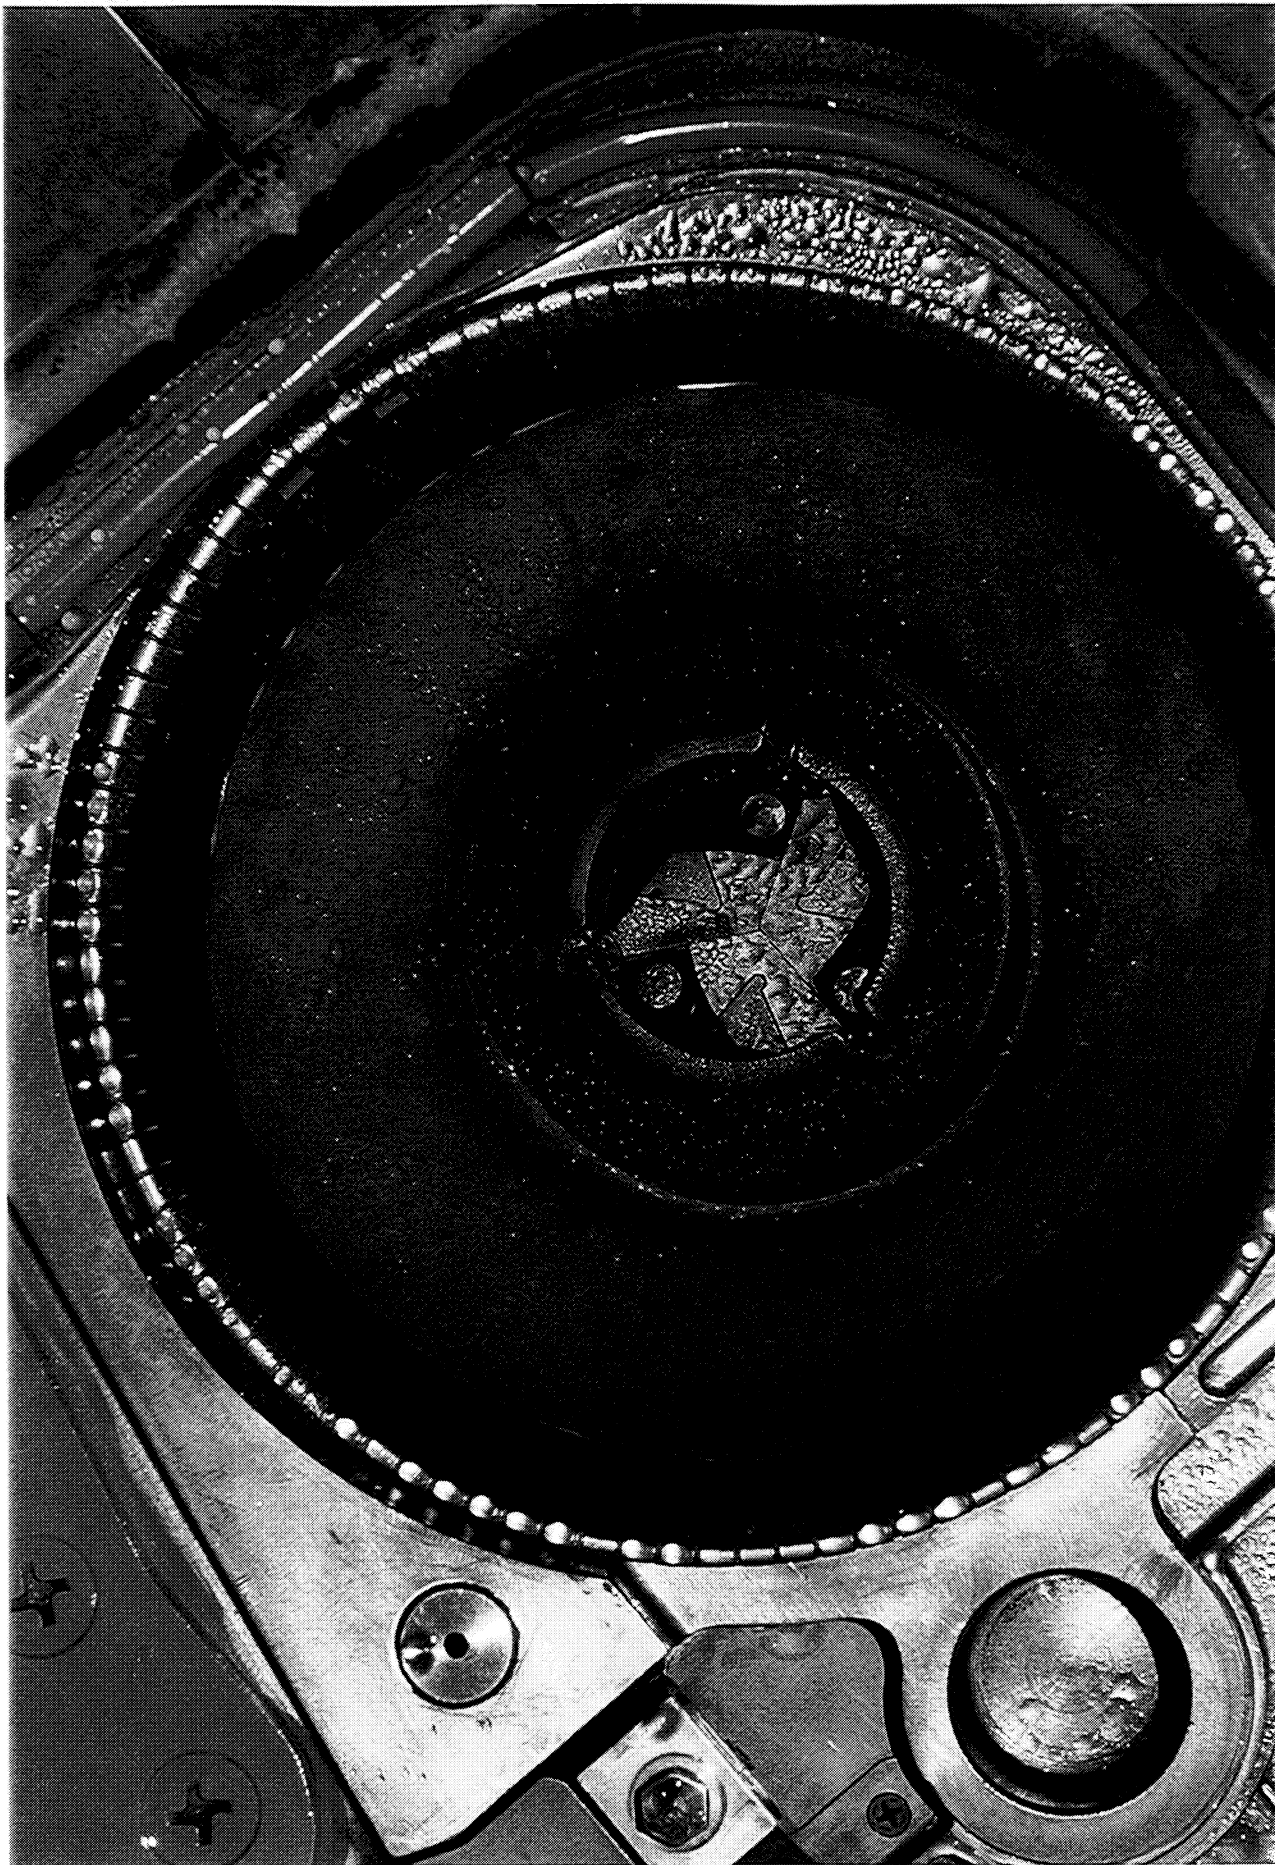
Photo 22: EO-2 Retainer Springs

The EO-2 retainer springs were dislodged. This condition has been observed on previous flights.

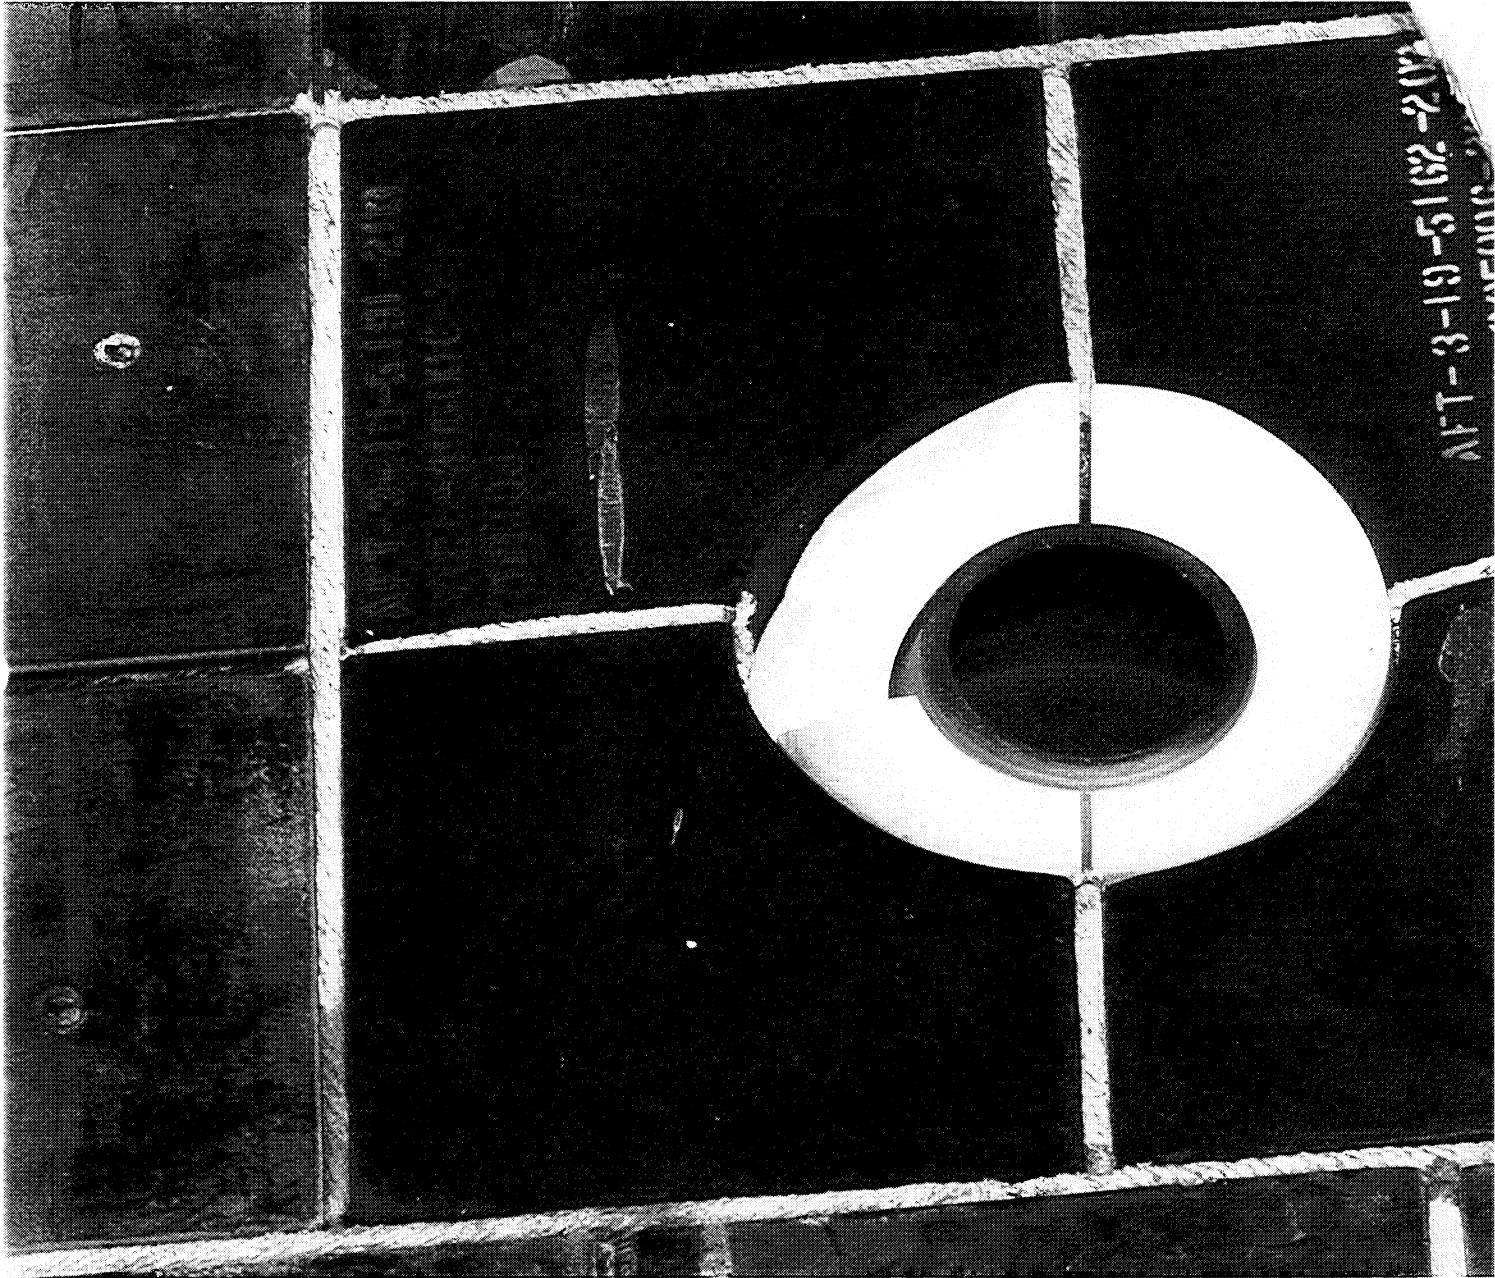
Photo 23: FES Thermal Isolator

An estimated 25-35 percent of the ceramic insulator surface area on both Flash Evaporator vents (aft fuselage near the body flap hinge) was missing to a maximum depth of 1-inch. Review of launch film item E-17 showed the insulator piece from FES #2 falling aft of the Orbiter during SSME ignition at 14:40:56.615 UTC. However, the missing piece from FES #1 could not be detected in the launch films and most likely was lost sometime later in flight. Both damaged insulators will be replaced, though this process requires the removal of 4 to 5 adjacent tiles at each port.

An estimated 25-35 percent of the ceramic insulator surface area on both Flash Evaporator vents (aft fuselage near the body flap hinge) was missing to a maximum depth of 1-inch. Review of launch film item E-17 showed the insulator piece from FES #2 falling aft of the Orbiter during SSME ignition at 14:40:56.615 UTC. However, the missing piece from FES #1 could not be detected in the launch films and most likely was lost sometime later in flight.

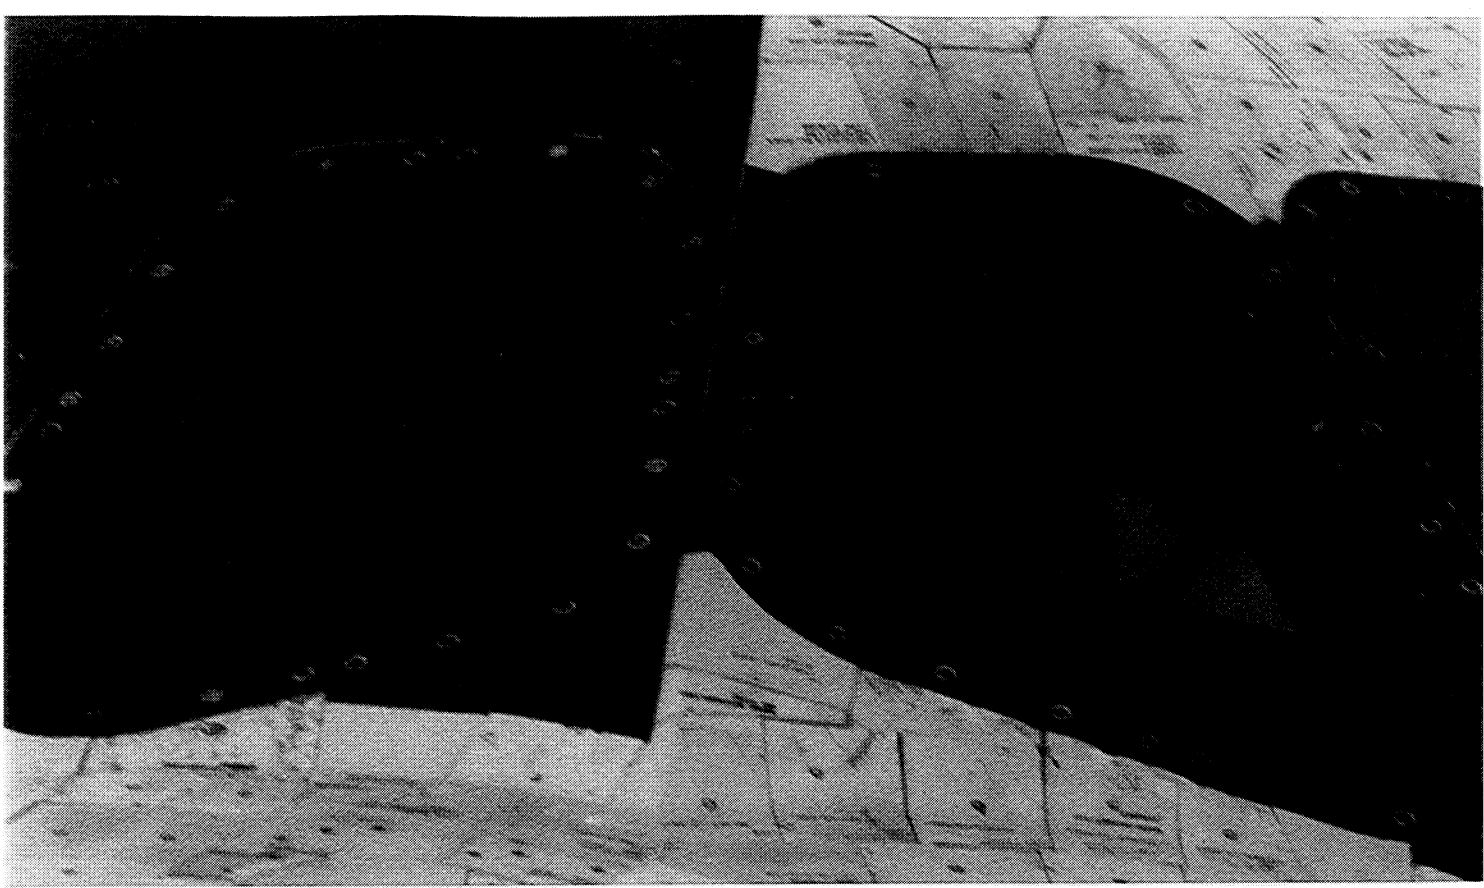
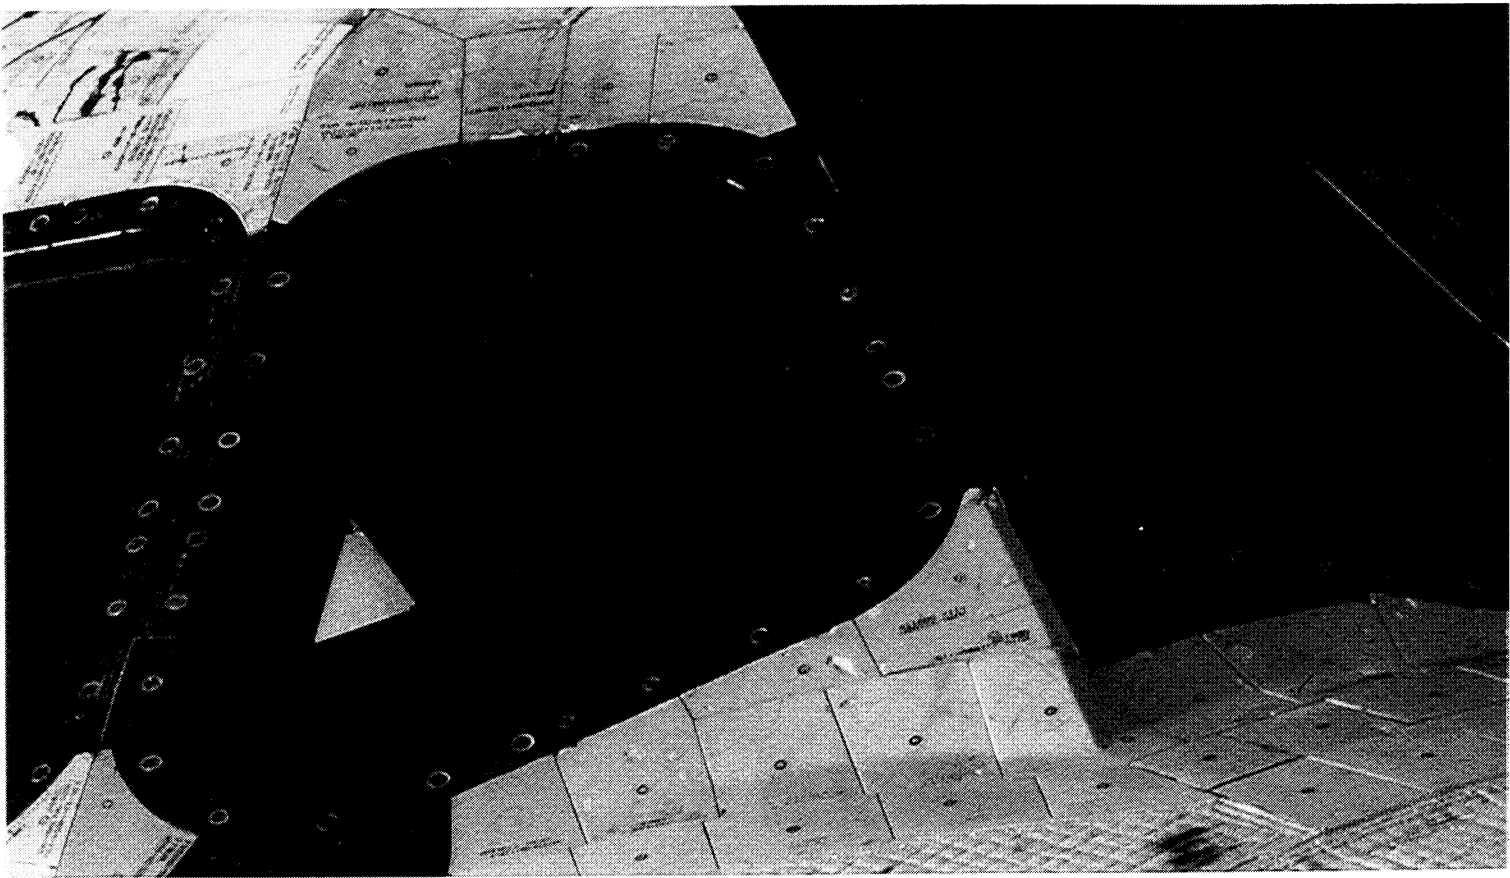
Photo 24: Windows and Perimeter Tiles

Hazing and streaking of forward-facing Orbiter windows was typical. Damage sites on the window perimeter tiles appeared to be average in size but more than average in quantity. The damage sites are believed to be the result of impacts from excessive RTV adhesive used in attaching paper covers to the FRCS thrusters.

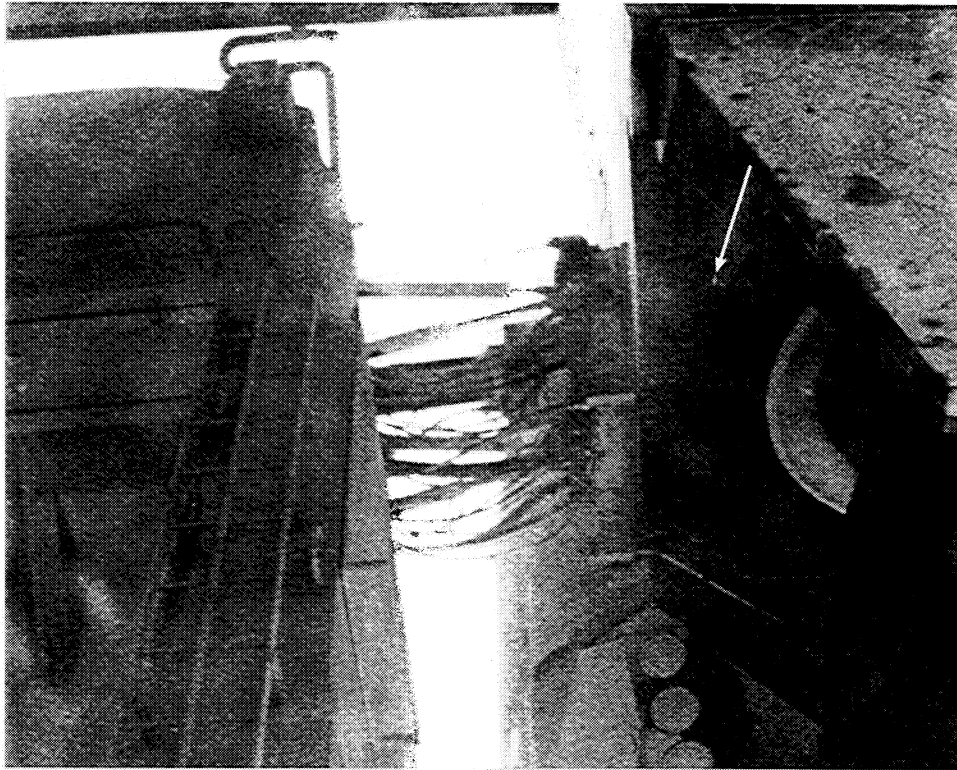
Figure 2.1 (A) Tile Surface Coating Material

A rectangular piece of tile surface coating material was seen to detach from the base heat shield outboard of the base of SSME #2 during SSME startup (14:40:55.505 UTC) (Camera E18).

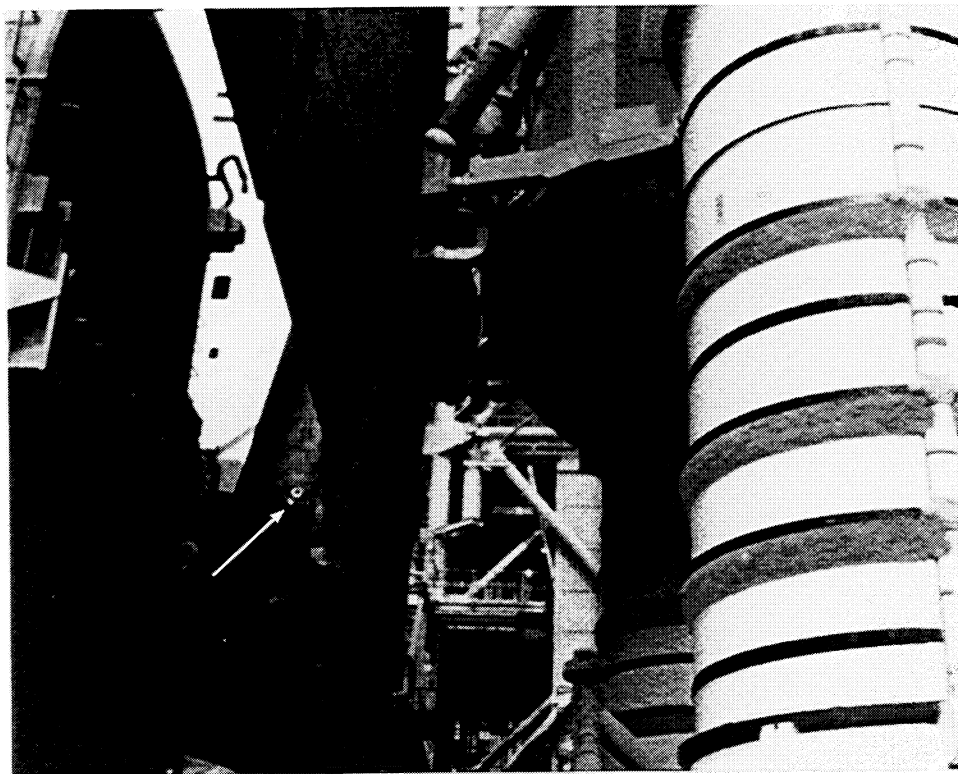
Figure 2.1 (D) Object Detached from FES Top Nozzle

A single, curved, light-colored object appeared to detach (or originate) from Flash Evaporator System (FES) nozzle number two on the right side of the aft fuselage during SSME ignition at 14:40:56.774 UTC (Cameras E5, E17). After landing, KSC reported that 25 to 35 percent of the ceramic thermal insulation surface area was missing on this FES nozzle to a maximum depth of one inch. KSC also reported that a similar amount of ceramic surface material was missing from FES nozzle number one on the port side of the Orbiter. However, the missing material from nozzle number one could not be detected in the launch films and was most likely lost later, in flight. KSC stated that both damaged thermal insulators will be replaced.

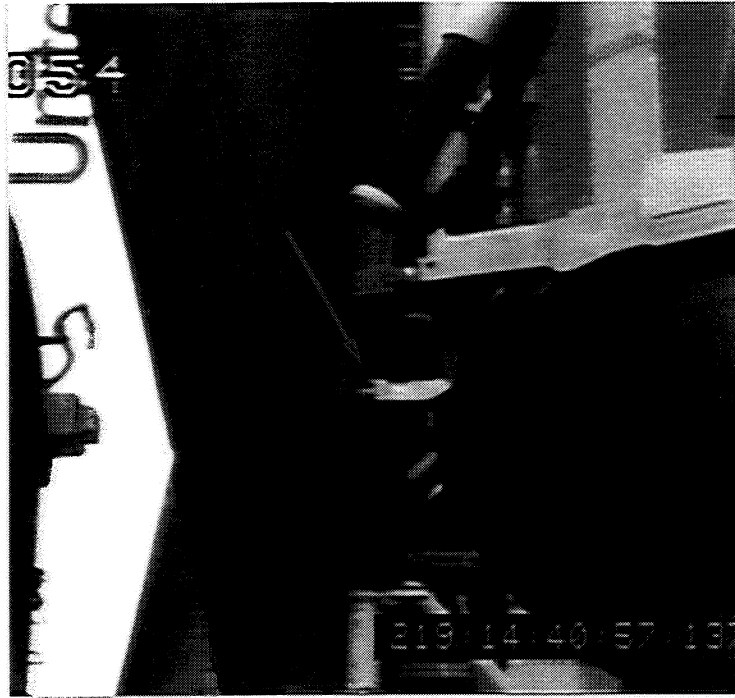
Figure 2.1 (E) Ice Debris from ET/Orbiter Umbilicals

A piece of ice debris from the ET/Orbiter umbilicals was seen to strike the ET/Orbiter LO2 umbilical electric cable tray during SSME ignition. No damage to the electric cable tray was visible (14:40:57.137 UTC) (Camera OTV054).

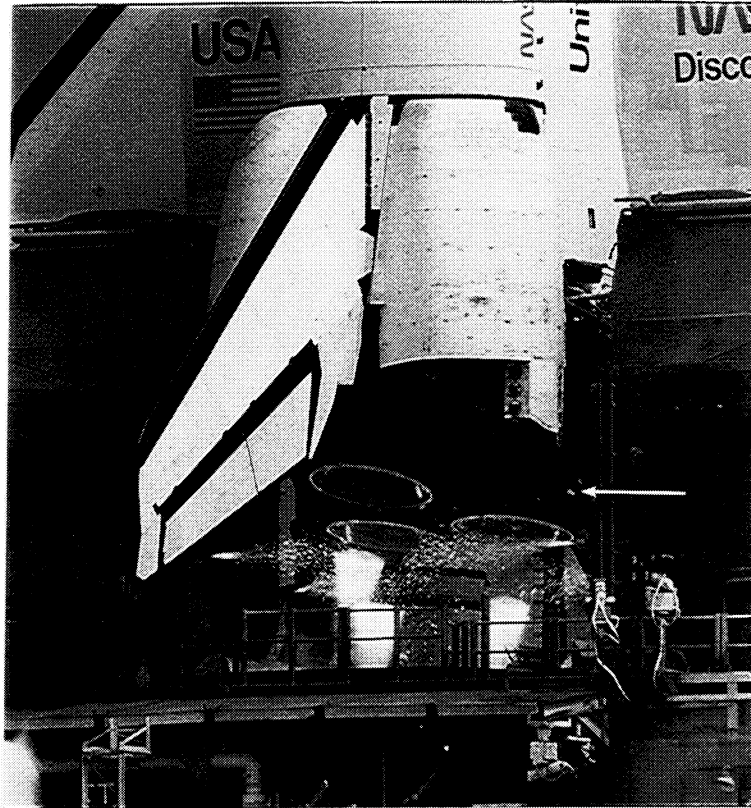
Figure 2.1 (F) Probable Ice Debris from LO2 TSM T-0 Umbilical Area

A large-appearing piece of debris (probably ice) was seen falling from the LO2 TSM T-O umbilical disconnect area prior to liftoff (14:40:58.1 UTC) (Cameras OTV070, E76).

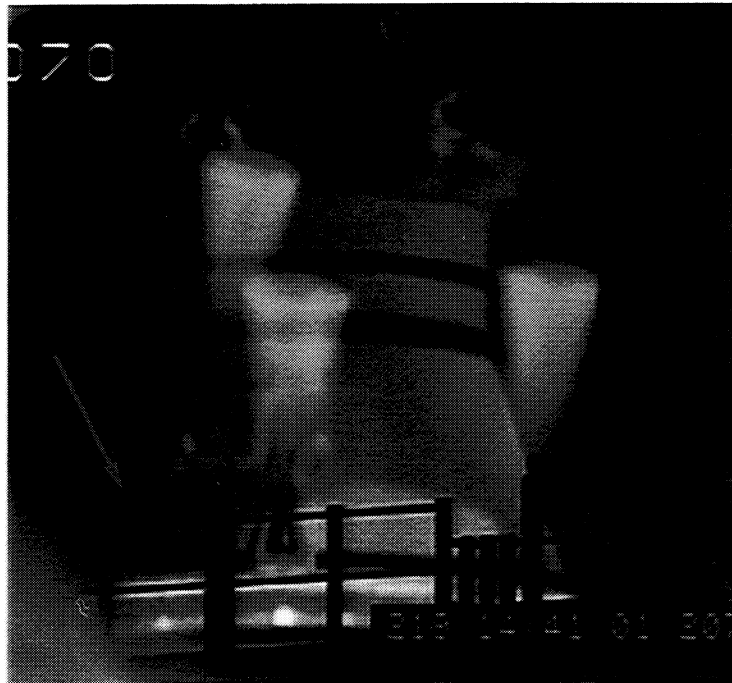
Figure 2.1 (G) Flame Duct Debris near SRB Skirts

Several pieces of SRB flame duct debris were seen between the RSRB aft skirt and the Orbiter, and near the LSRB aft skirt during liftoff (14:41:01.2 UTC) (Camera OTV63).

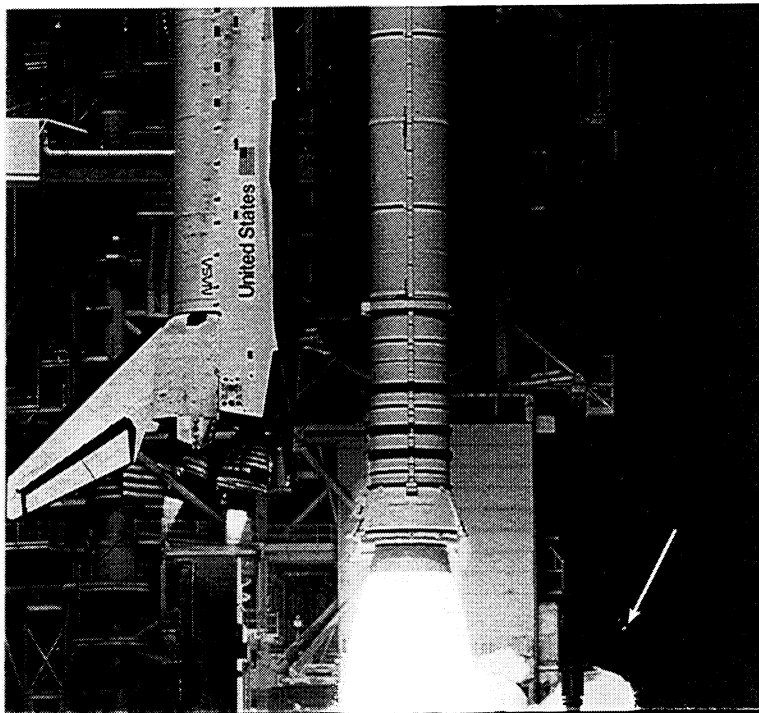
Figure 2.1(H) SRB Flame Duct Material

A single large-appearing light-colored piece of SRB flame duct debris traveled north away from the vehicle during liftoff at 14:41:02.148 UTC (Camera E52).

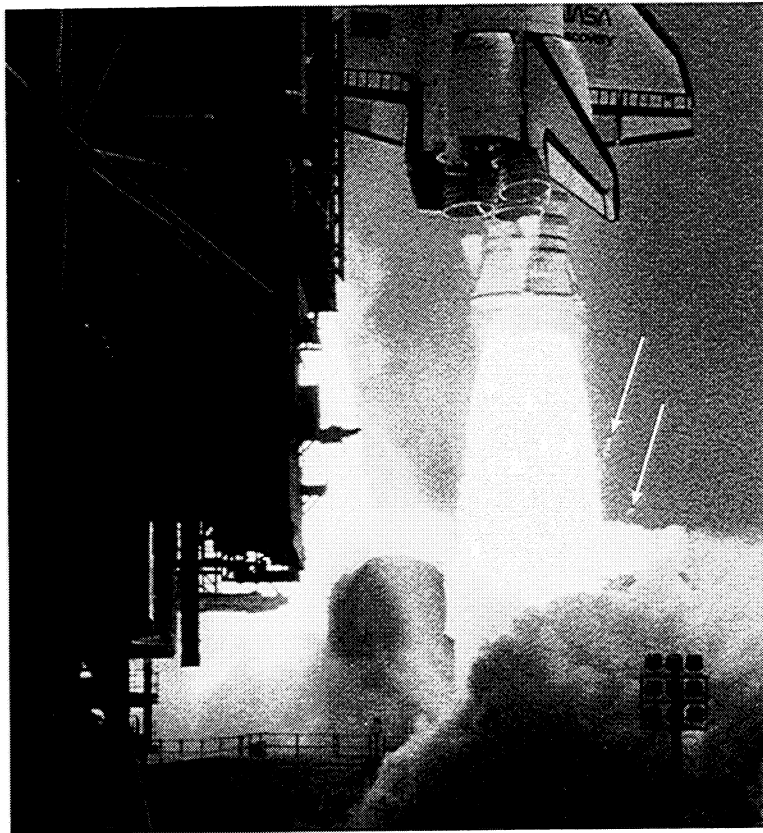
Figure 2.1 (I) Objects with Smoke Trails

Several pieces of debris with smoke trails, which appeared to come from the flame duct, were seen exiting the RSRB plume during liftoff (14:41:02.78 through 14:41:03.085 UTC) (Cameras E2, E20, E63). It is possible that the smoky debris were particles from the large chunk of insta-foam that detached from the RSRB aft skirt during liftoff, which is reported in paragraph 2.3, MLP Events. Water baffle debris and several additional pieces of SRB flame duct debris were also seen in the exhaust cloud after liftoff. None of the debris were seen to contact the vehicle.

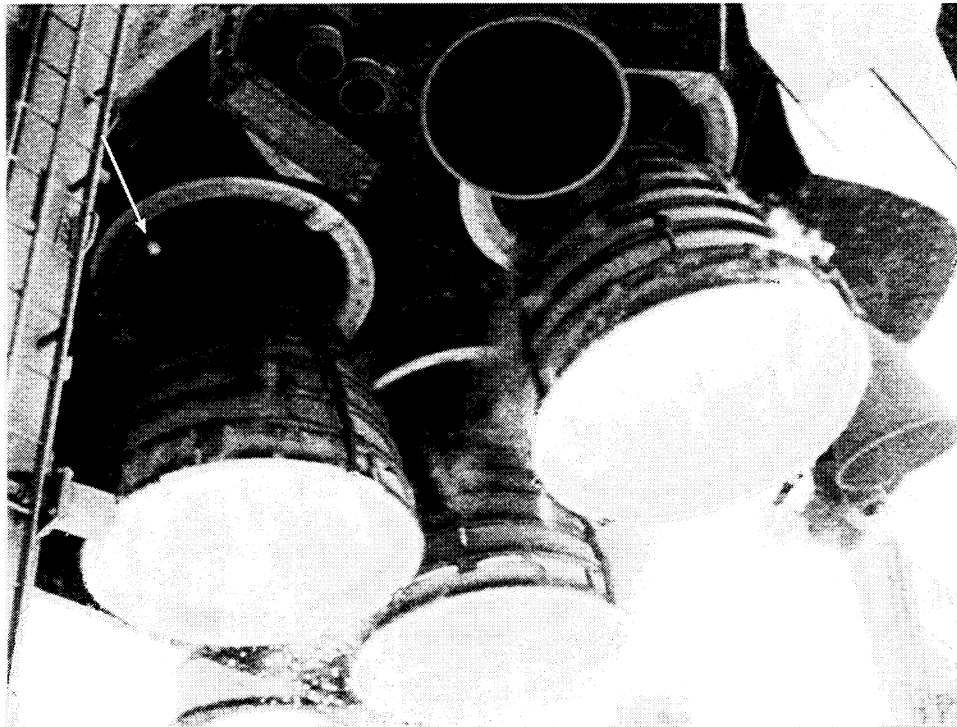
Figure 2.3 (B) Orange-colored Area on SSME #2 Heat Shield

A bright orange-colored area (probably a light reflection) was on the SSME #2 engine mounted heat shield from SSME ignition to liftoff (14:41:00.8 UTC).

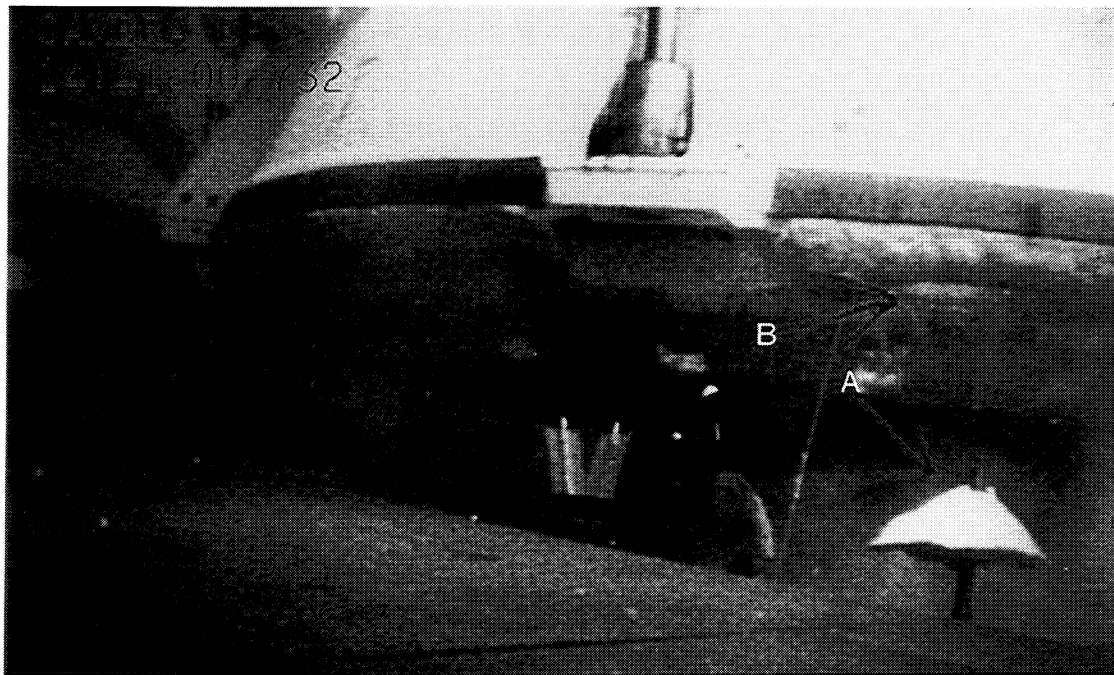
Figure 2.3 (C) Insta-foam Attached to Nitrogen Purge Line

A large thick piece of insta-foam (A), approximately 12 inches in diameter, was pulled loose from the right SRB aft skirt (B) as the launch vehicle lifted off. The foam remained attached to the gaseous nitrogen purge line (Camera E8). The
